Налог за пловидбеност ваздухоплова

НПВ 19-02-01

ПРЕДМЕТ: Замена склопа разводног зупчаника 4-цилиндричних магента типа *Slick 4200*, *4300* или *4700 (LASAR)*, произвођача *Champion Aerospace LLC*.

SUBJECT: Potential decreased service life of Slick 4-cylinder magneto distributor gear assemblies. **Based on process and component improvements following the initial release of this service bulletin, the serial number range is being extended in this revision. Magnetos previously returned for compliance to SB1-15 must be returned or inspected for compliance to this revision SB1-15A.**

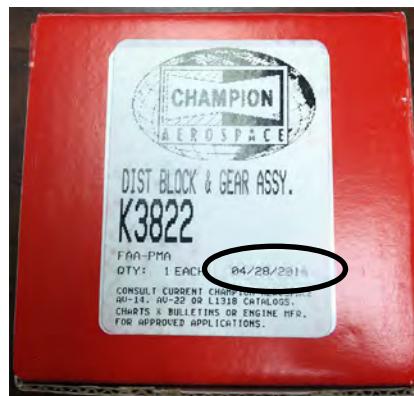
Figure 1. Replacement Kit Box Label Date Code

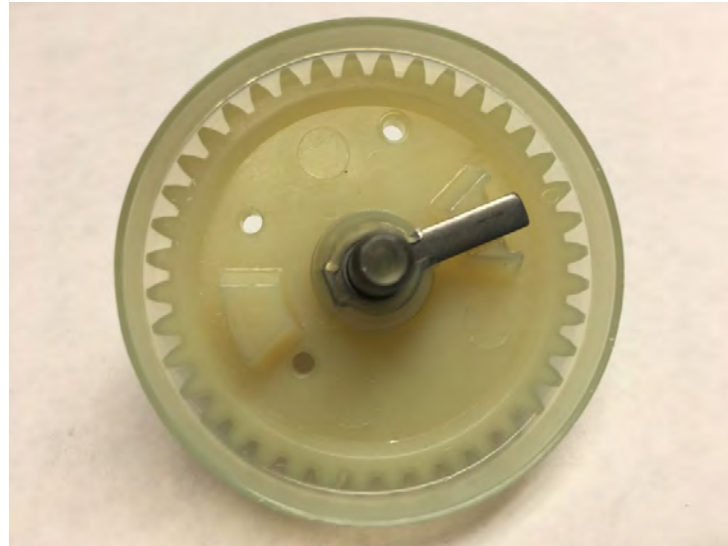
Figure 5. K3008 Distributor Gear With Monel Electrode

If it is not possible to confirm the version of the distributor gear that is installed in a given magneto from maintenance records, the magneto may be removed from the engine in order to have the housing and distributor block removed to allow visual inspection of the distributor gear. Distributor gears with Copper electrodes must be replaced with distributor gears with Monel electrodes.
